## Grafton Verge Fusee Restoration Ca. 1760

The following shows some the restoration work involved of an early English Verge Fusee watch. The owner of the piece is a watch collector but not overly familiar with the early English workmanship and entrusted me to bring the watch back to good working order and detail the case, dial, hands as best possible.

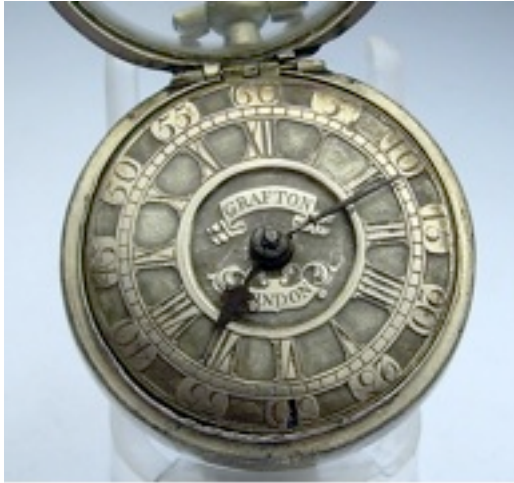
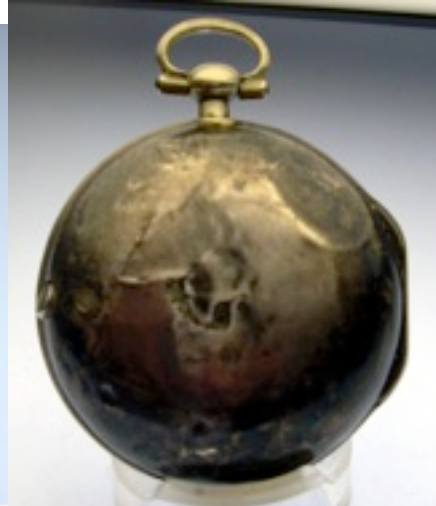
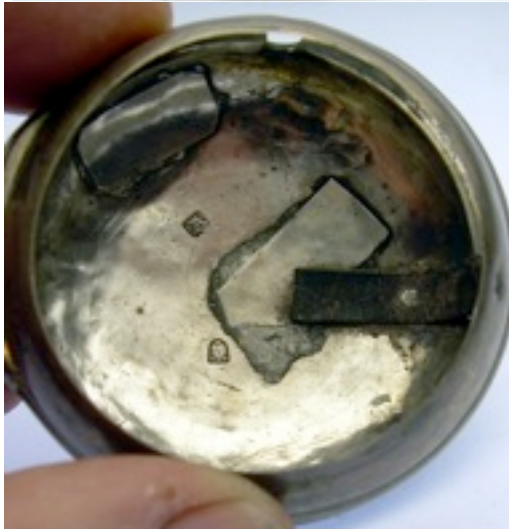
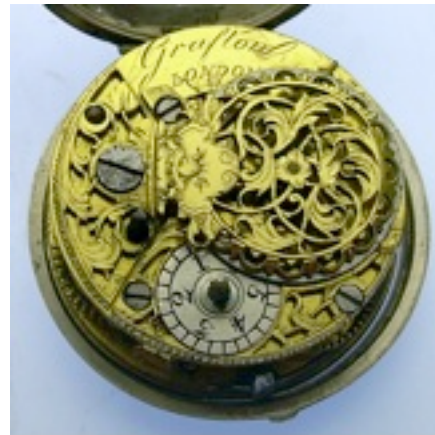
Upon initial examination of the watch, I found the piece to be reasonable well preserved, but with some mechanical wear and some cosmetic issues that could both be resolved. The case, silver hallmarked, showed a lot of wear (through), some repairs from the past using lead based solder, making it rather difficult to do anything with it, sort of re-shaping (tapping out dents) and polishing.

The following images are of the watch as it was received.

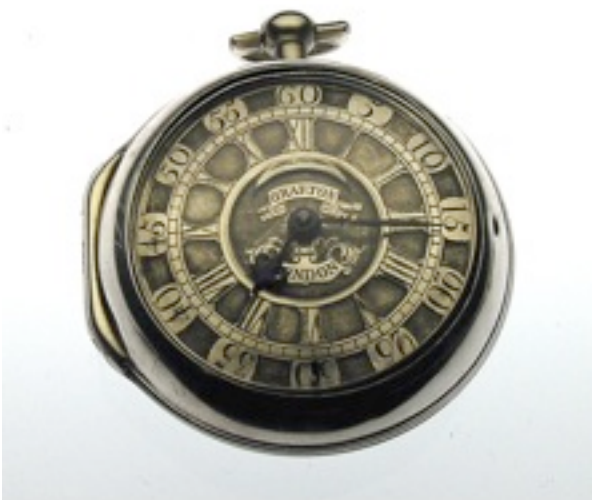
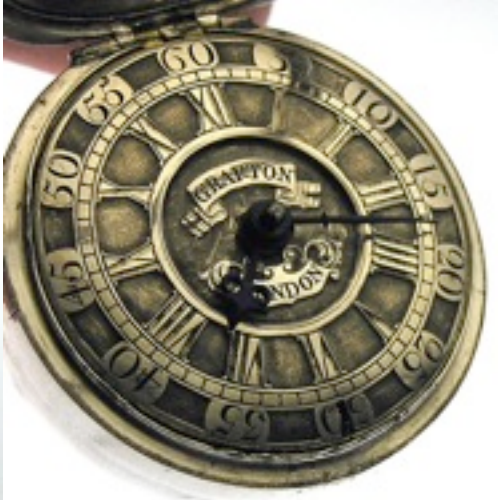
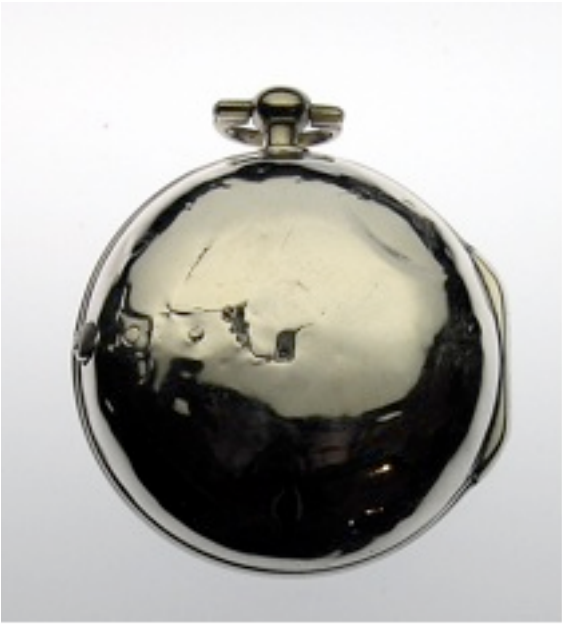
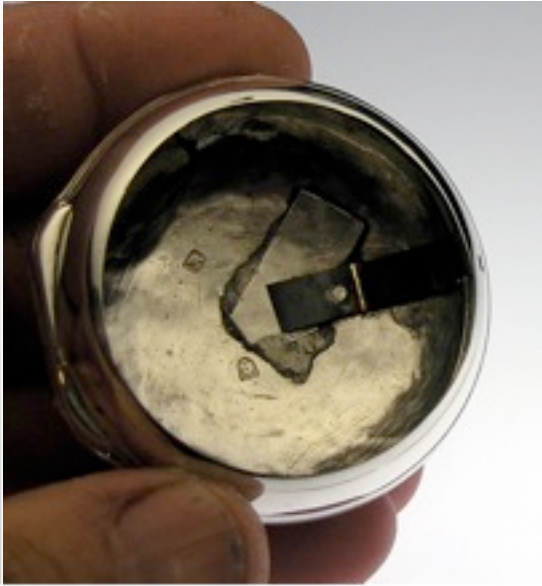
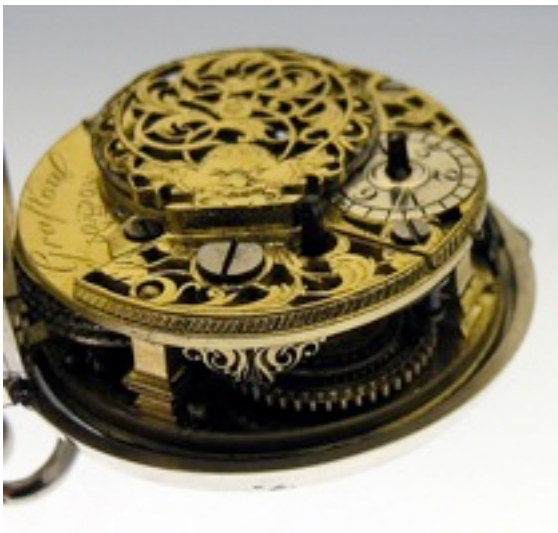
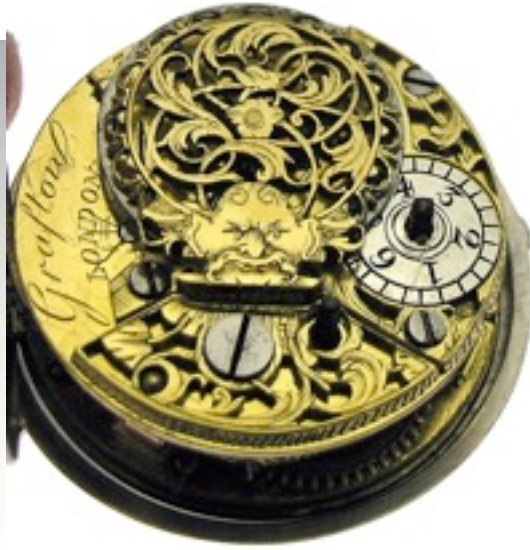
The Finished Product

The watch timed out exceptionally well for a piece that was over 230 years old. The customer was extremely pleased with the results. (Please see “Customer Testimonials” John and Mary W.)

The case dents were then tapped out, all surfaces were detailed with polishing compound and the dial was cleaned, lightly polished and the engraving filled with black. In addition, I also fitted the case-back with a new steel catch-spring as the old one was no longer doing its job.

Once all the necessary repairs were made, the watch is then re-cleaned and assembled with a new mainspring and the watch is tested.
