Restoration of an Eternamatic Gents Wristwatch – ca. 1940

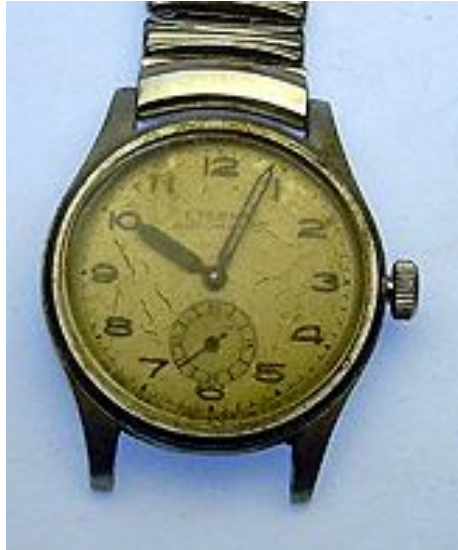
This is what the watch looked like when it came in. The brand name was barely recognizable through the discolored crystal and the age and water damage as evidence on the face.

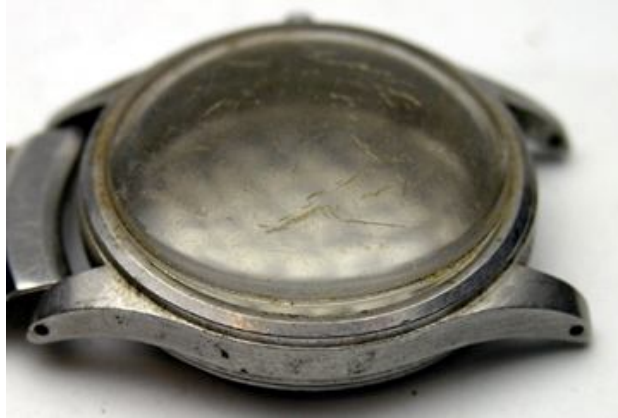
The case, as can be seen in the following image, is filthy, shows minor scratches and abrasions and is clearly not a presentable piece to wear. Also note how the crystal is not only yellowed, but also crazed with little stress cracks as will happen after many years of neglect.

The watch case gets a full make-over too. The steel is resurfaced with a satin wheel from the buffing machine. The areas that require high polish are also treated. Then the case is cleaned ultrasonically, rinsed and dried. A new crystal is selected and fitted.

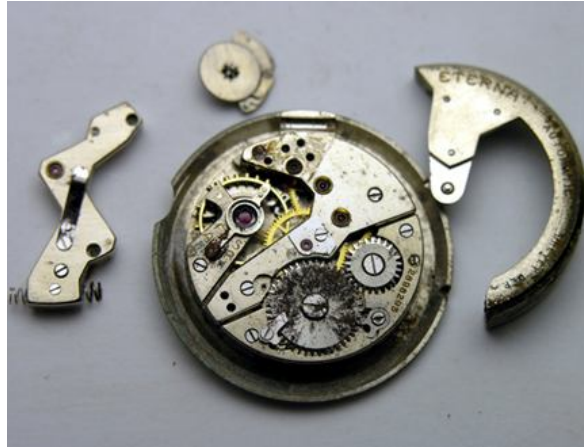
Once the movement was removed from the case, it became evident that the watch had sustained significant water damage to the mechanism. With the self winding mechanism removed, clearly there is rust on the winding wheels, the regulator, the self-winding weight and a number of screws. There is likely some rust also on the pivots of the gear train that have prevented the watch from operating properly.

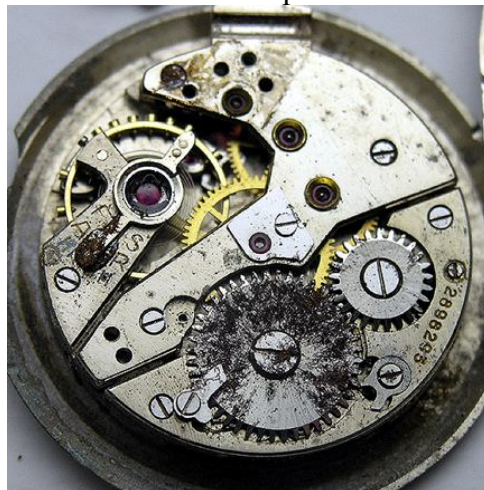
Here's a close-up of the movement to further illustrate the pervasiveness of rust on the wheels and plates.

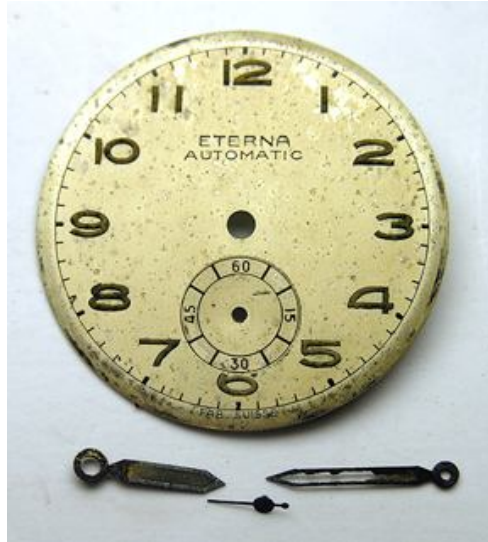
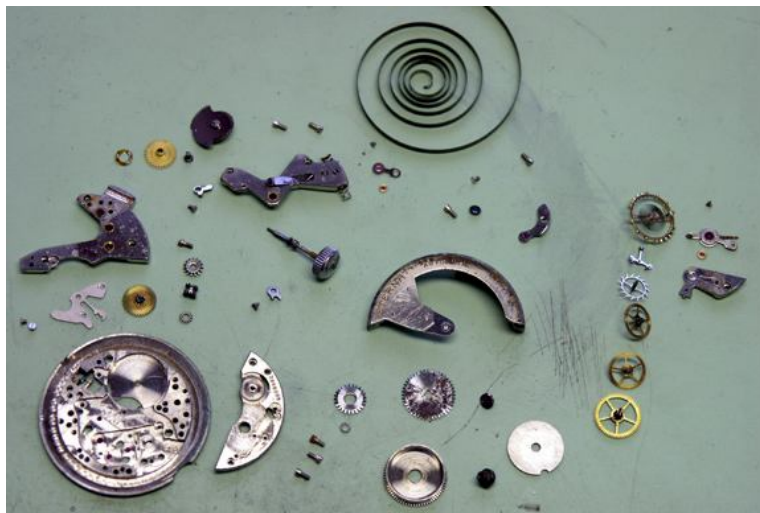
With the dial removed, there was less corrosion on the front plate, but clearly, the dial and hands also sustained damage from the water that penetrated the case. The luminous material on the numeral has been stained, the lacquer covering the silvered finish has peeled away and the surface of the dial has also become compromised. Also note that the hands have begun to rust and the luminous material is nearly black. Some has even fallen out.

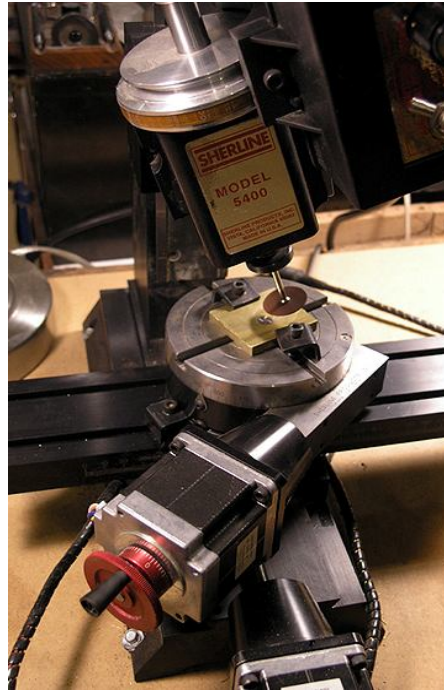
The ratchet wheel was particularly corroded and required a significant amount of re-finishing. The wheel was first cleaned with a fiberglass brush and then applied to a fine Arkansas slip to determine the amount and depth of the pitting. Once it was clear that the pitting was significant, it was decided to re-surface the wheel and replicate the original finish as closely as possible.

The wheel was glued to a brass block and then held in clamps on a rotary table of a 4 axis milling machine. The milling head was inclined in such a way as to offer an angled finish to the wheel.

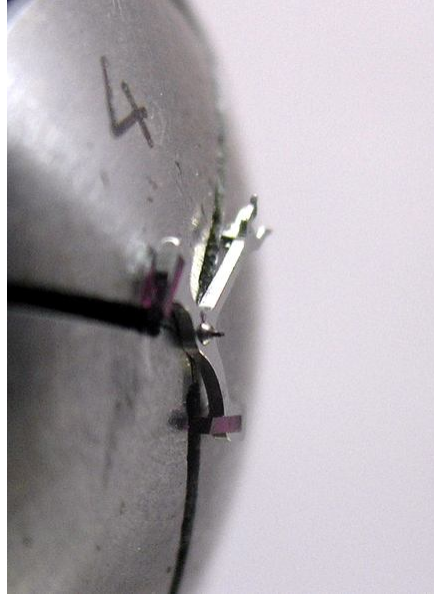
Here, the pallet fork top pivot had some rust that required cleaning up and burnishing to bring it back into good order. The lower arbor is mounted in a .4 mm lathe chuck and the top pivot is dressed with an Arkansas slip followed by progressively finer grades of emery paper.
