## **Restoration of a Model 1857 American Watch Co. (Waltham) Pocket Watch**

The following is an example of what a restoration entails. The watch in this case has seen nearly 150 years of use and was in rough condition. Mechanically and cosmetically, there was a lot of work to perform.

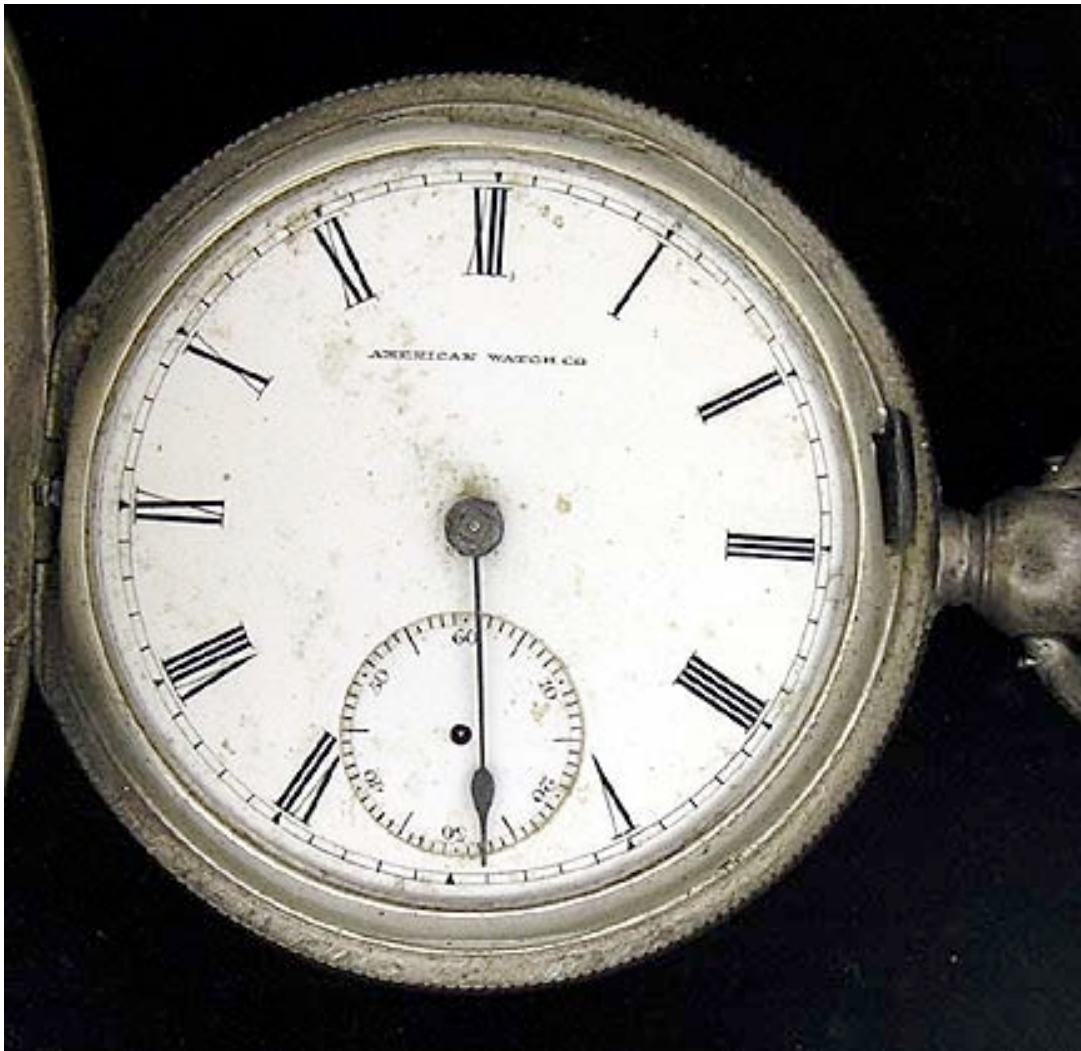
The case – The wear on the case was significant, but is still a good functional and original coin silver hunter style case. There were dents on both front and back covers and many surface scratches on all three. The bow was attached with a sewing pin and the crystal was missing. Additionally, both the second hand and hour hand were missing and the minute hand was showing signs of corrosion.

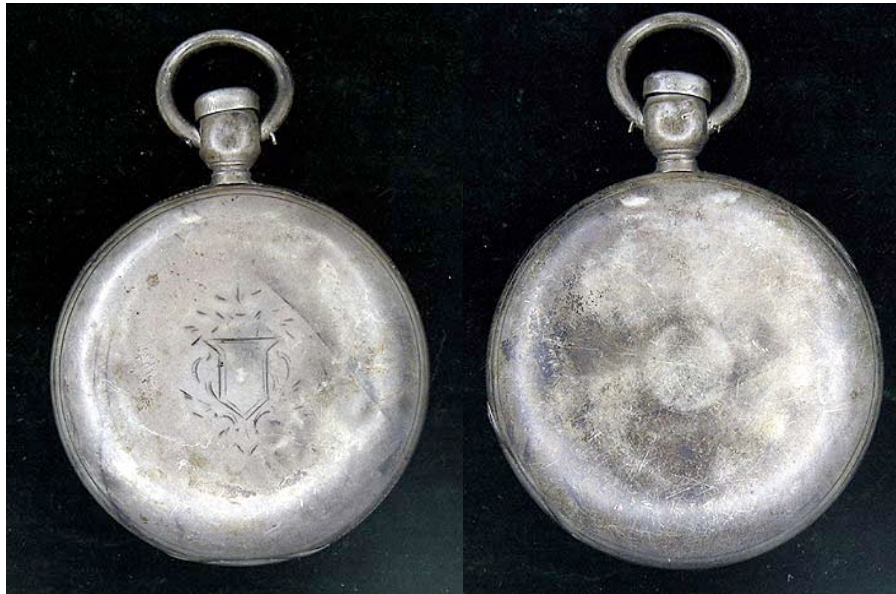
The Movement - Mechanically, the watch was complete, but filthy dirty with oil that had dried to such an extent that many of the wheels were bound up tight in their bearings. There was one balance wheel jewel that was cracked, but the balance pivots were not broken and would only required a polishing. The mainspring was set, meaning it had lost a lot of its original strength.

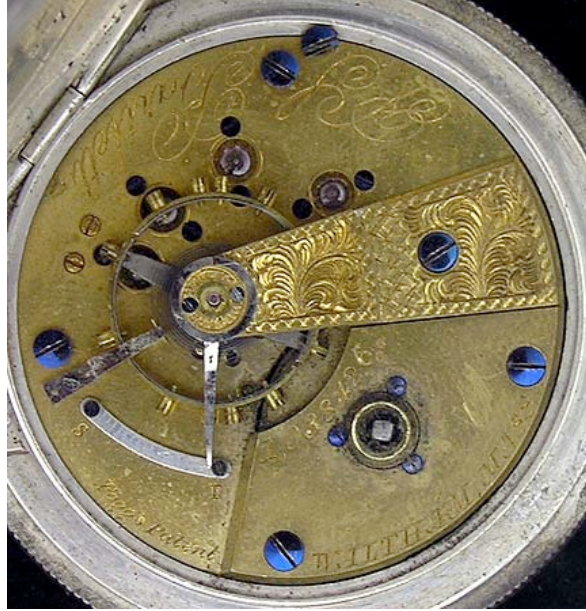
1. The first task was to disassemble the entire works including the removal of cap jewels and detail what might be needed in order to bring it back to good operating condition. Note the dirt, dust and lint and lack of luster on the movement parts. Also note how the mainspring in its relaxed state opens to a small diameter. This is a sign of a weak spring and the watch will assuredly benefit from a new spring.

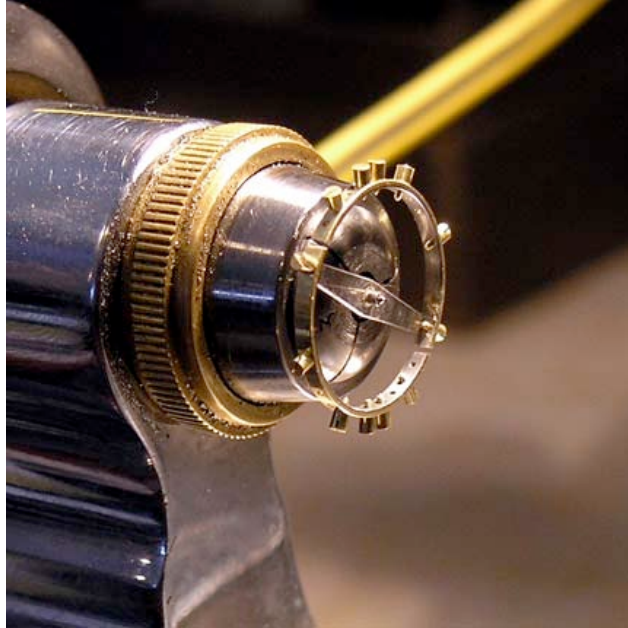
4. With a new mainspring greased and fitted into the barrel, the watch is assembled. The balance wheel has a good action in one position, but the top pivot shows signs of wear, likely caused by the watch being used for a long period with a cracked jewel. The hairspring is removed and the balance is chucked up in the lathe and a polish is offered to the top balance pivot as well as the bottom.

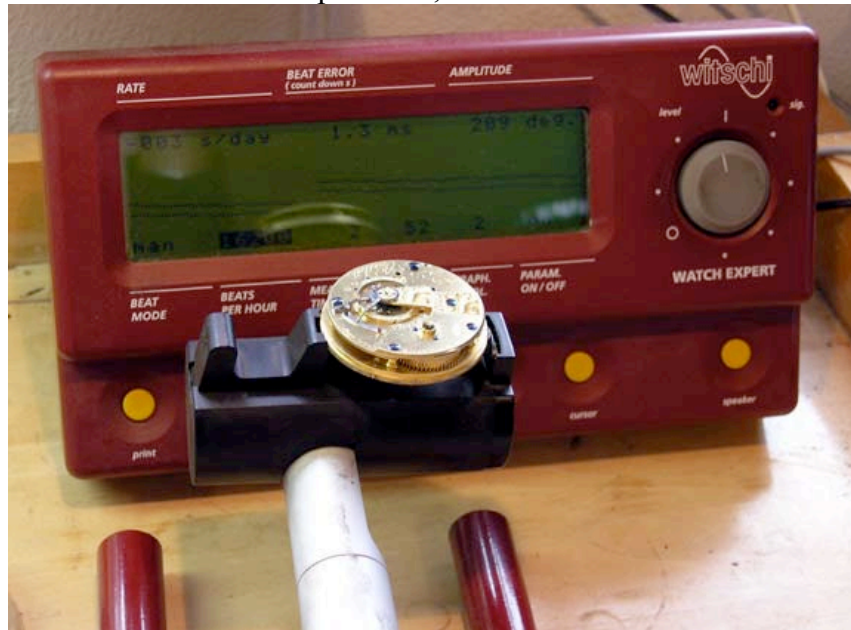
5. The watch is tested again and the timing machine offers a good diagnosis. The rate appears well and the amplitude is better than anticipated for a watch of this age. In vertical and horizontal positions, the watch offers little variance.
