## Grafton Verge Fusee Restoration Ca. 1760

The following shows some the restoration work involved of an early English Verge Fusee watch. The owner of the piece is a watch collector but not overly familiar with the early English workmanship and entrusted me to bring the watch back to good working order and detail the case, dial, hands as best possible.

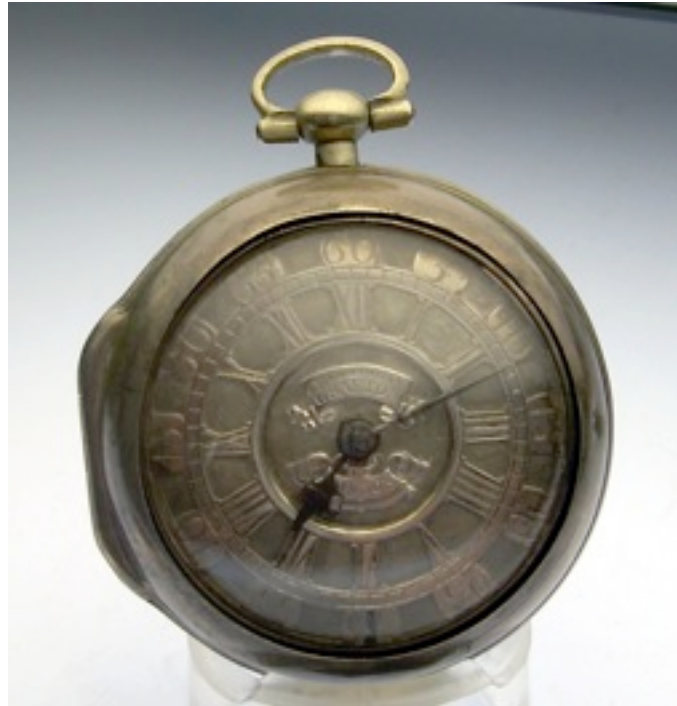
Upon initial examination of the watch, I found the piece to be reasonable well preserved, but with some mechanical wear and some cosmetic issues that could both be resolved. The case, silver hallmarked, showed a lot of wear (through), some repairs from the past using lead based solder, making it rather difficult to do anything with it, sort of re-shaping (tapping out dents) and polishing.

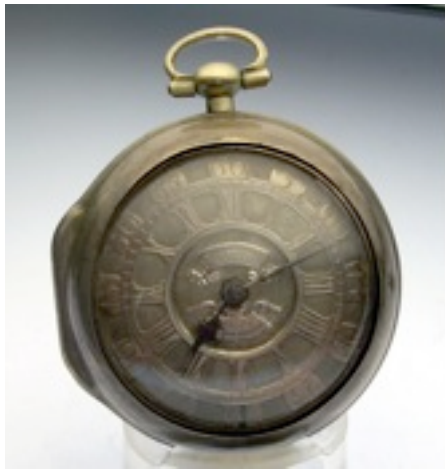
The watch timed out exceptionally well for a piece that was over 230 years old. The customer was extremely pleased with the results. (Please see “Customer Testimonials” John and Mary W.)
